## FERRULE & CLAMP CONSIDERATIONS FOR KURI TEC® HOSE & TUBING

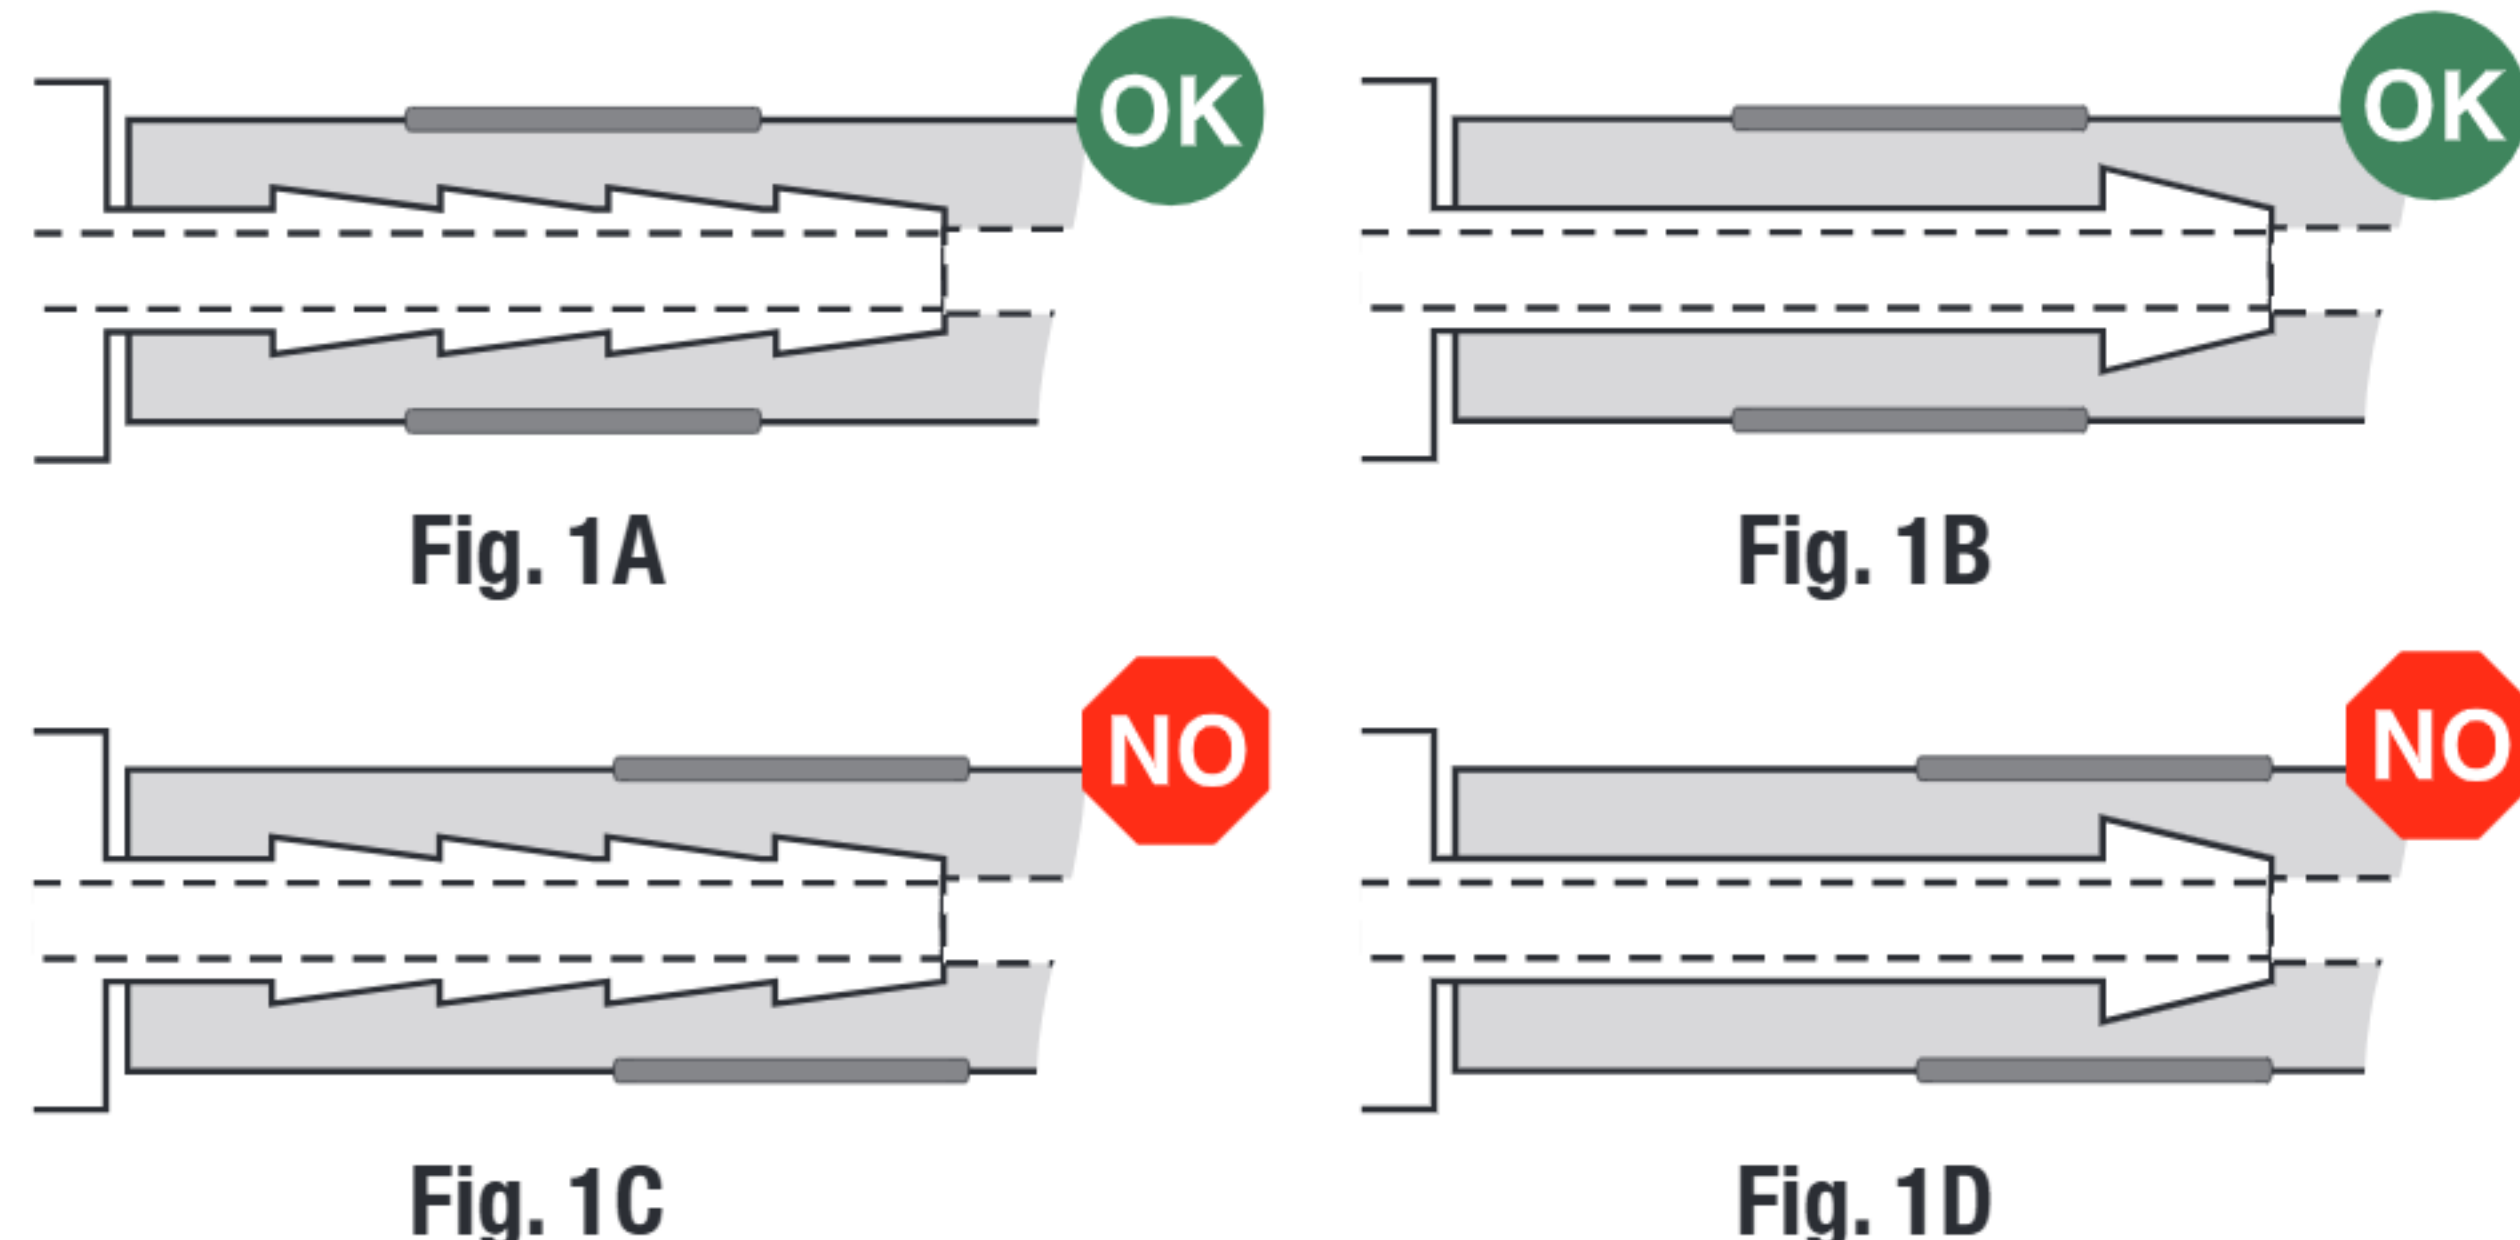
### MULTI BARB FITTINGS SINGLE BARB FITTINGS

In the illustrations above, the clamps are properly positioned in Figure 1A and 1B, directly over the middle barbs and behind the first barb. This is extremely important in the case of single-barb fittings, as shown in Figure 1B, since the barb is generally much larger than the shank of the fitting. The compressed material cannot pass over the barb when under tension, thus securely holding the fitting to the hose.

In Figures 1C and 1D, the clamp has been improperly positioned too close to the end of the fitting. In Figure 1C, only the barb nearest the end of the fitting is effective in maintaining fitting retention. The first two barbs serve no purpose whatsoever in providing fitting retention or leak resistance. In Fig. 1D, the situation is even worse, since the clamp can very easily cut the core tube over the enlarged barb, leading to leakage and subsequent cover blisters or bursts.

When choosing multi-barb fittings for use with Kuri Tec hose, as in Fig. 1A and 1C, it is important that the barbs not be too deep. The core tubes in Kuri Tec hoses are generally somewhat harder than conventional rubber tubes and therefore the material cannot flow into the deep barb, as it would with a soft rubber compound.

In addition to the properly installed fittings shown in Fig. 1A, 1B, 2A and 2B above, we also suggest the use of a two-barb clamped fitting when high pressures are involved.

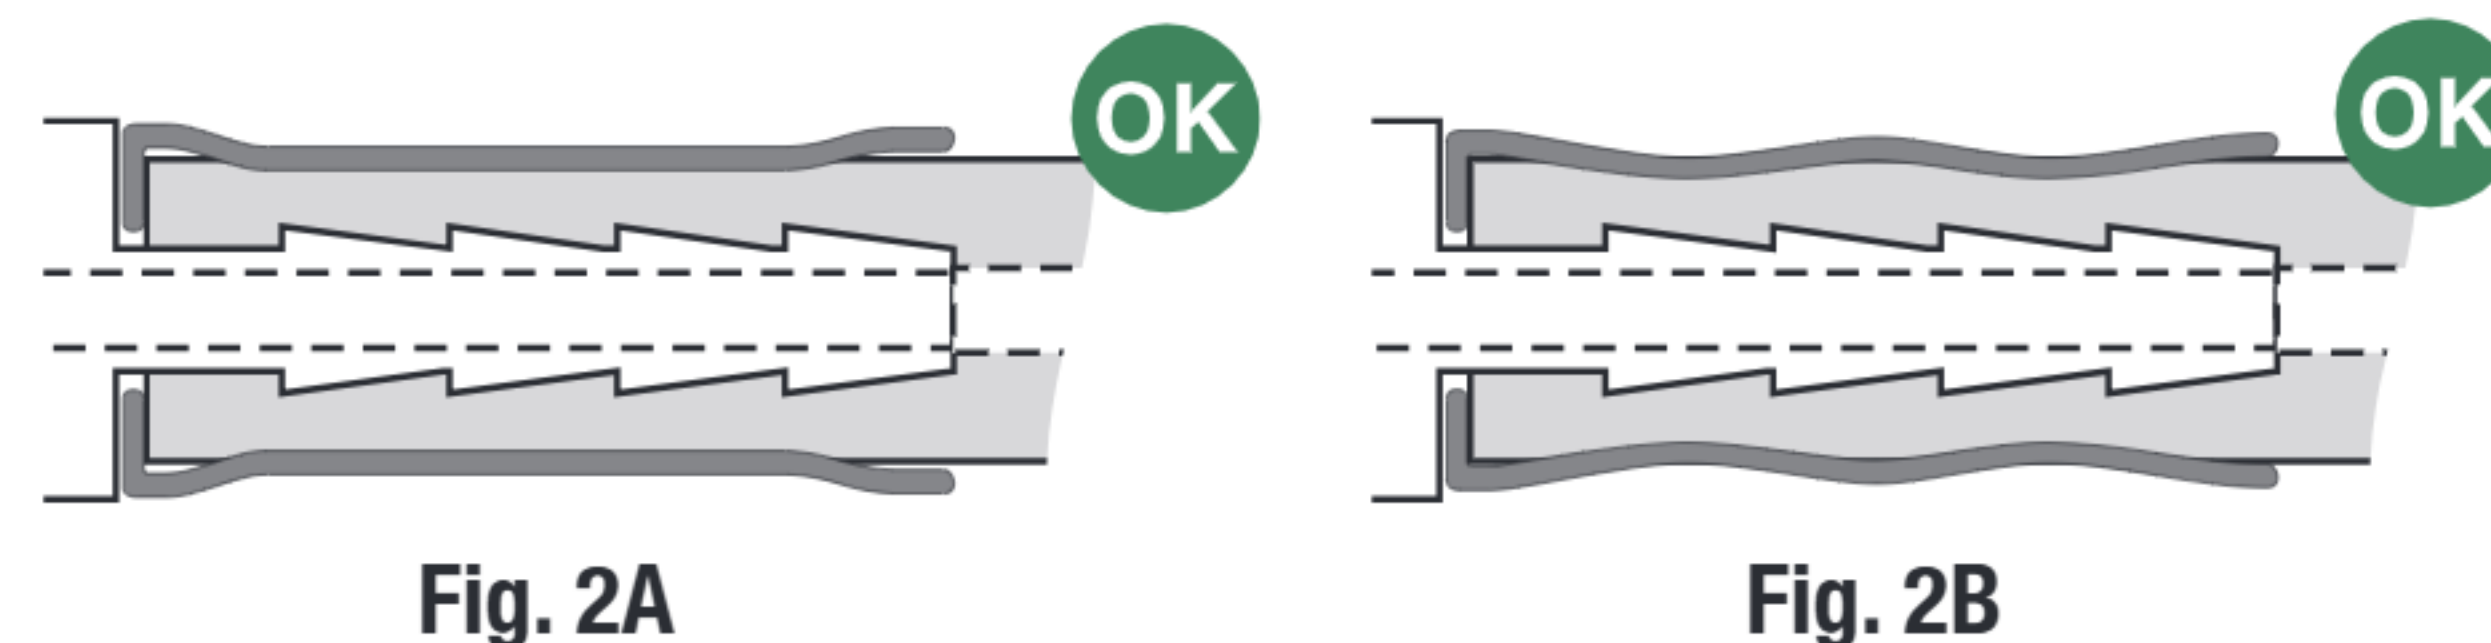
In figures 2A and 2B above two styles of crimping die have been used successfully. The ferrules and fittings are properly matched in length.

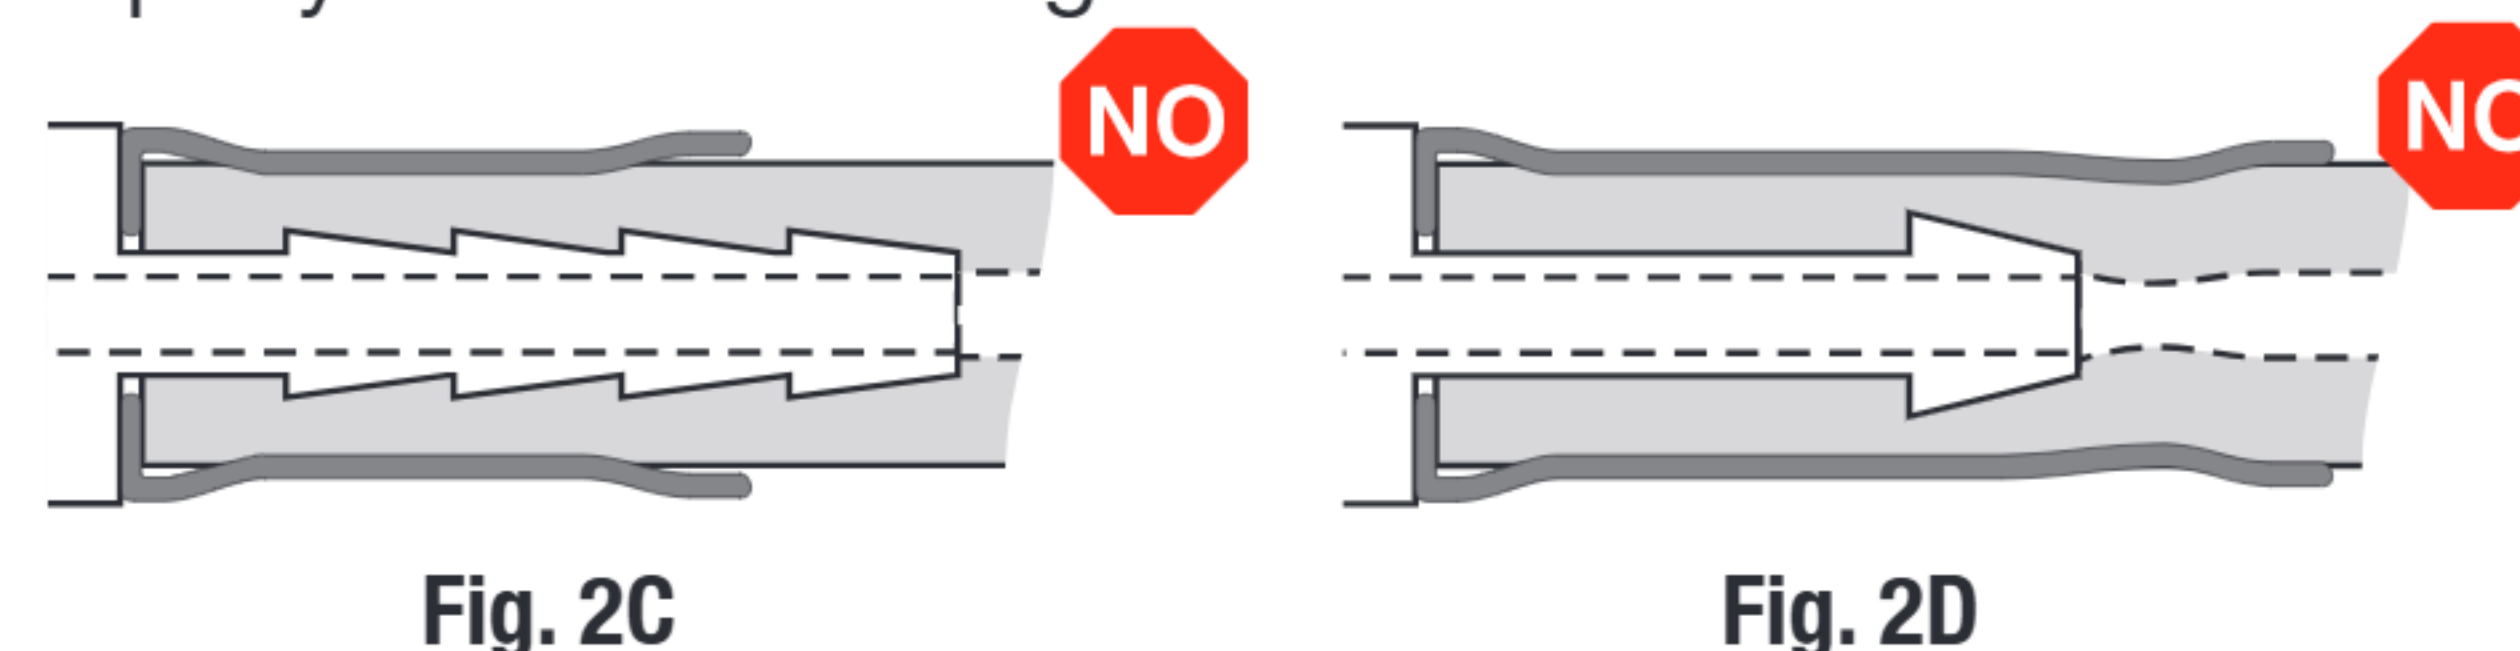
In Fig. 2C, the ferrule is much shorter than the barbed insert. Without the protection of the ferrule, repeated harsh flexing of the hose at the fitting can damage the tube. In addition, the short ferrule does not take full advantage of the sealing or retention properties of the barbed insert.

In figure 2D, there are two potential problems: 1) The excessively-long ferrule can reduce the inside diameter of the hose just beyond the fitting; and 2) a single-barb fitting is not the ideal insert for a crimped ferrule. Because of the increased depth of the single barb, the tube can be cut by the force of the crimping before sufficient compression is exerted on the shank of the fitting.

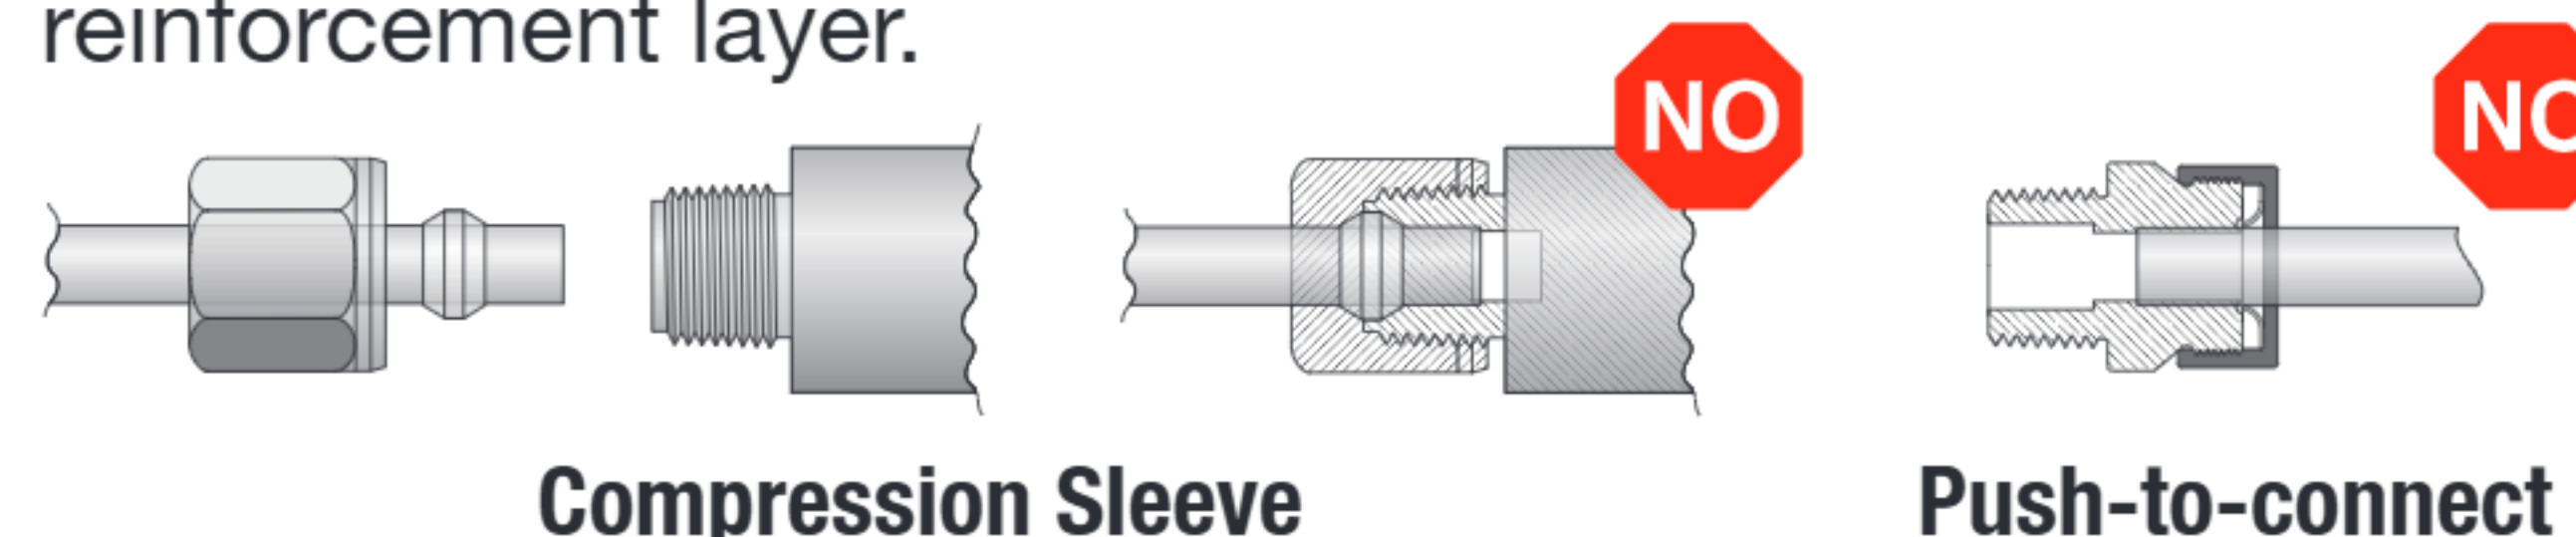
### COMPRESSION FITTINGS

Compression fittings depend solely on contact with the outer surface of the tubing to provide sealing and holding power. There is no seal on the inner surface of the tubing. With the exception of 220/221 Series LLDPE tubing, we do not recommend the use of compression fittings with Kuri Tec hose and tubing. To work properly, the material must be hard and smooth and there must be no yarn reinforcement layer.

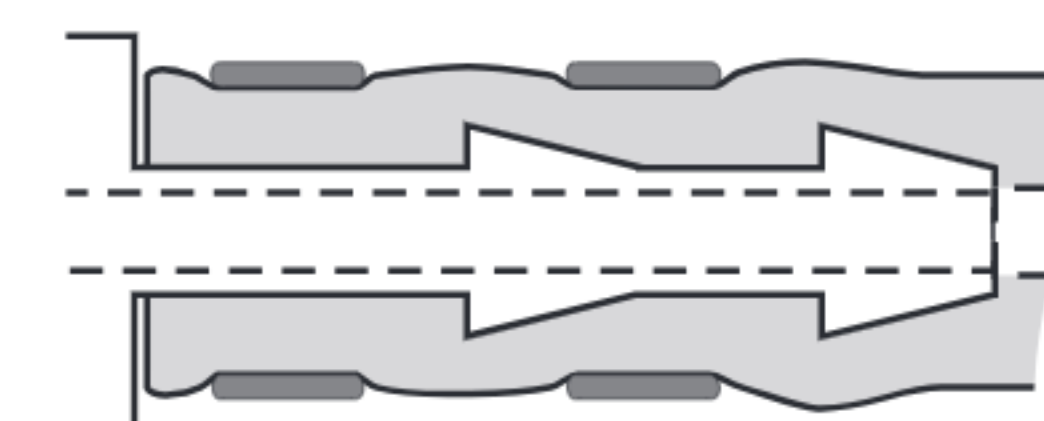
The double-barb fitting, held in place by two properly positioned clamps, provides excellent fitting retention and leak resistance without risk of damage to the core tube or deterioration of the yarn reinforcement due to wicking.

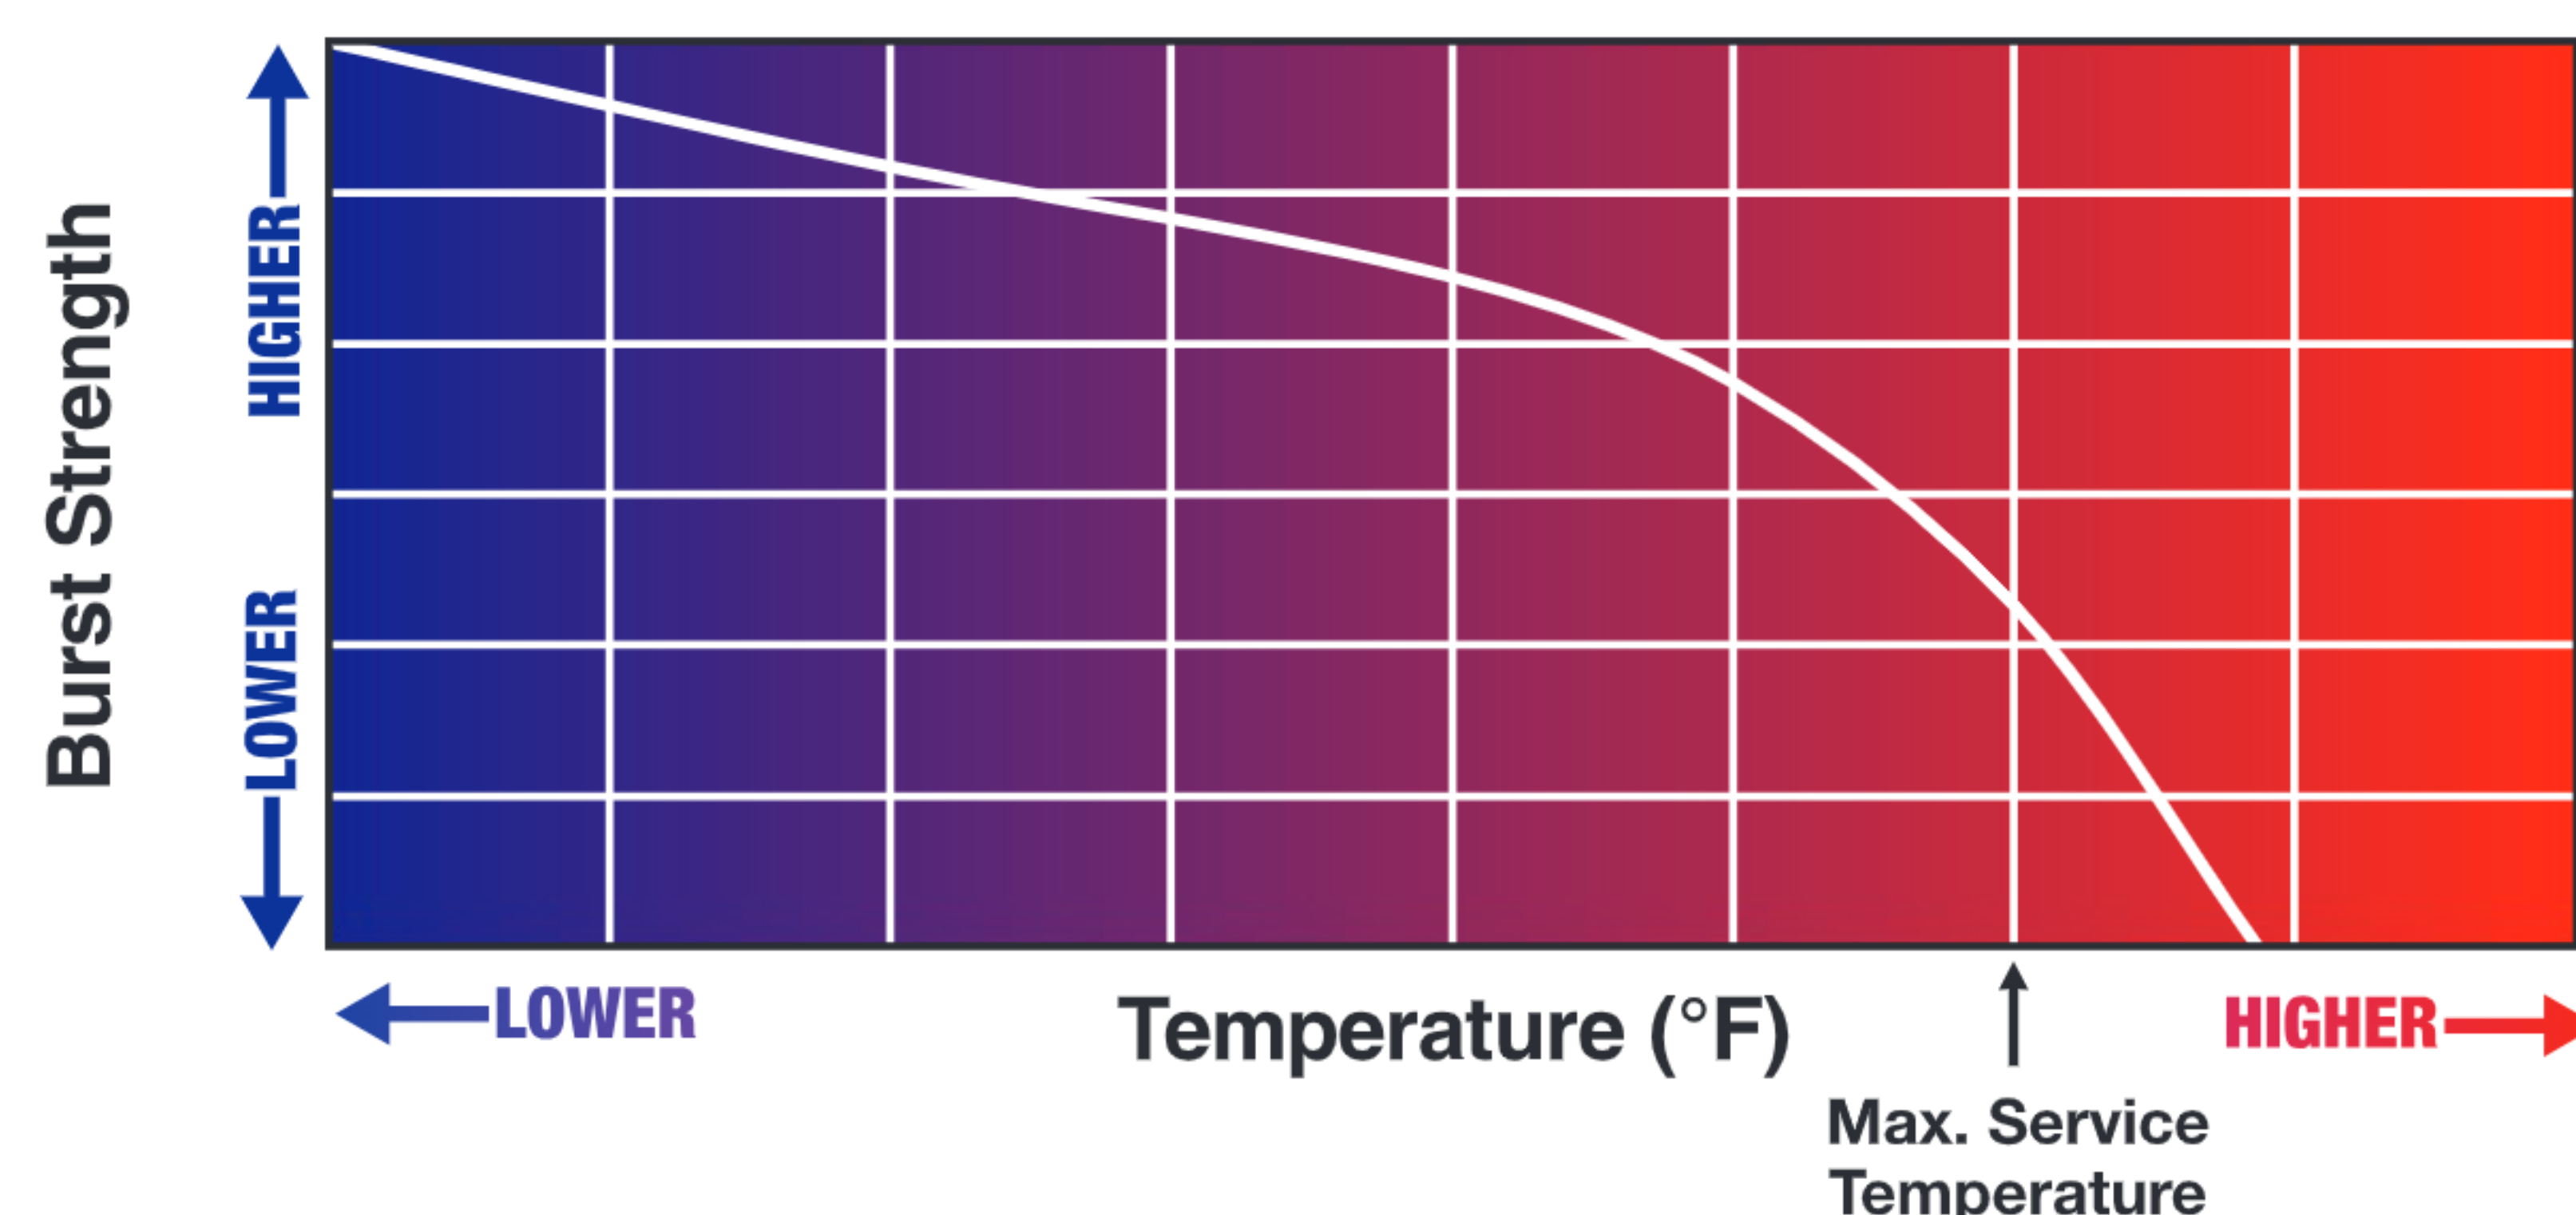
### ***Burst strength decreases as temperature increases***

As a general rule, the working pressure ratings for plastic reinforced hoses are based on room temperature conditions. The maximum allowable pressure for a hose decreases as the temperature increases and the material becomes softer and more elastic. Fitting retention decreases at higher temperatures as the compression on the material declines.

Working pressure ratings can be affected significantly by the type of fitting used, the method of attachment, and the temperature to which the hose assembly is exposed in service. Repeated intermittent periods of exposure to elevated temperatures can affect fitting retention and it is, therefore, very difficult to assign working pressure ratings at high temperatures. The graph below demonstrates the overall trend.
